**White Paper**

**Domestic Water Quality and Distribution System  
Remediation in an Institutional Facility**

By David Roach, CPD

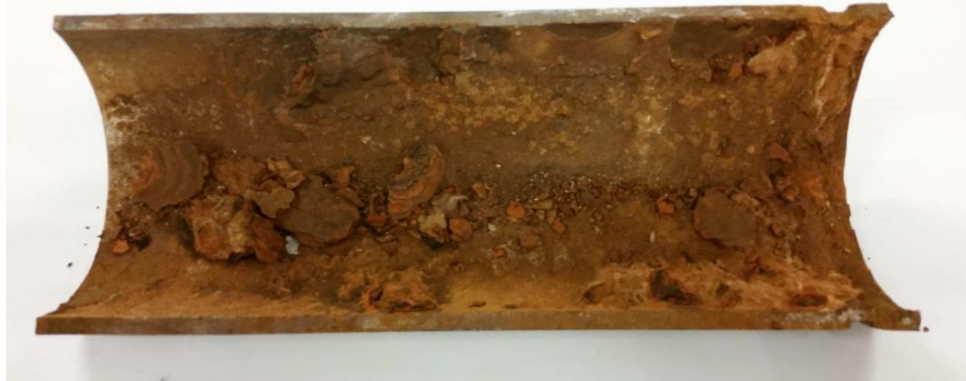
*Figure 1: 4" Horizontal Galvanized Steel Domestic Cold Water Pipe*

The photos on the previous page show substantial tuberculation (rust deposits) caused by corrosion due to the low-alkaline water. This is the source of the discolored and poor tasting water in the building. Additionally, the rust can and does flake off the pipe wall only to foul water heaters, valves and faucets in the plumbing system. Curiously, the existing copper pipe, also in the domestic water distribution system (hot water distribution and cold and hot water branch pipe), revealed little to no degradation of the internal pipe wall from representative samples taken for analysis.

the underlying steel. This corrosion results in the formation of iron oxides (rust) at the site of the initial penetration of the zinc layer. Corrosion mechanisms result in a higher corrosion rate underneath the iron oxide tubercles, which results in more iron oxides. As can be seen, this self-catalyzing process can result in rapid deterioration of, or failure in the pipe wall.

What do we do about the existing deteriorating steel piping and elevated levels of lead, zinc and copper in the system? It certainly does not make sense to continue using the existing deteriorating distribution infrastructure, outdated lead-containing plumbing fixtures and lead-fouled domestic water heaters with the new acid neutralizing system. All of the existing steel piping in the domestic water distribution system will be removed and replaced with copper pipe. Additionally, all of the lavatory faucets, sink faucets and drinking fountains will be replaced with lead-free versions under the current guidelines, as well as replacing the gas-fired domestic water heaters.

One hurdle to overcome is that the building will be fully occupied and operational during construction. In order for the building to remain open and operational, the plumbing systems must be maintained in operation. This is addressed by building a completely separate copper pipe domestic water distribution system running in parallel with the existing system which allows the existing system to continue to serve building needs during construction. Once the new domestic water distribution system and acid neutralizing system is completed, disinfected, and commissioned into service, the existing copper pipe runouts to bathroom groups and individual plumbing fixtures can be decoupled from the existing steel distribution pipe and connected to the new copper pipe distribution system. After all the existing plumbing fixtures and equipment have been decommissioned from the old steel pipe distribution system and connected to the new copper pipe distribution system, the existing steel piping distribution system can be removed.

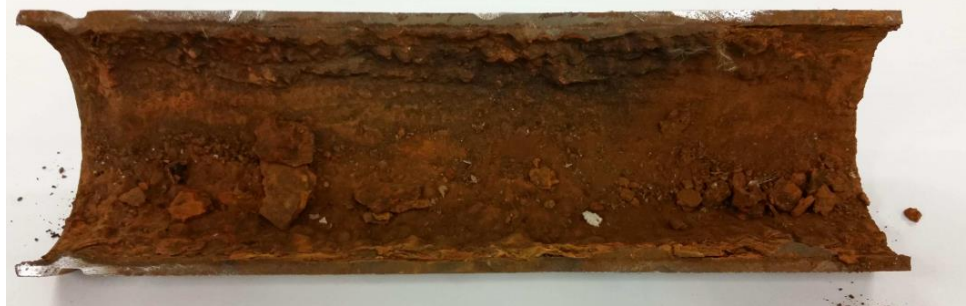
*Figure 2: 3" Horizontal Galvanized Steel Domestic Cold Water Pipe*

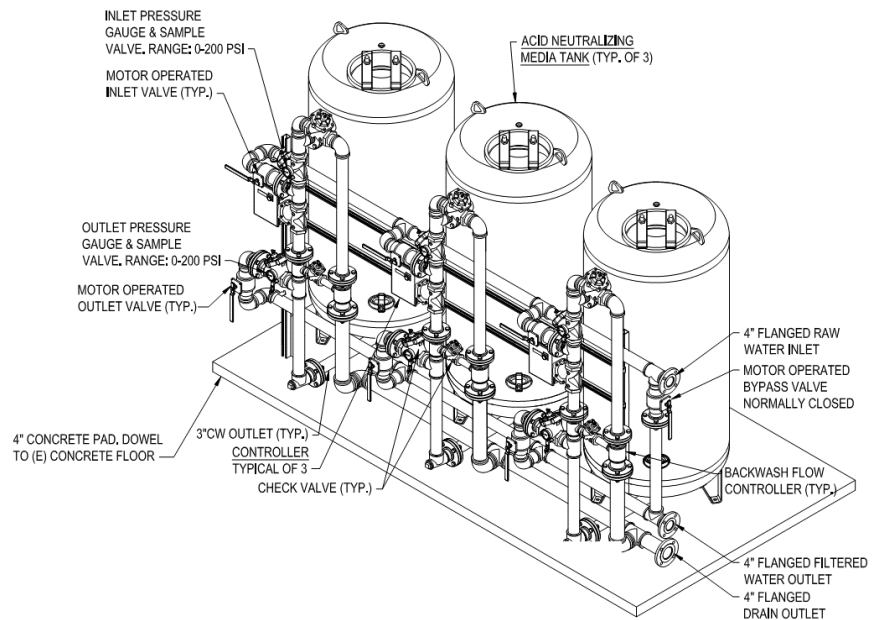
Figure 3: Acid Neutralizing System

So how do we fix this mess you might ask? The building’s water quality is influenced by the low-alkalinity of the water supply causing steel pipeline corrosion and elevated levels of metals through the liberation of lead, zinc, and copper. To reduce pipeline corrosion and the release of metals into the water means we must increase the alkalinity of the water by adding  $\text{CaCO}_3$  prior to water entering the building’s domestic water system. This is accomplished by running the incoming raw water supply through an acid neutralizing system (see Figure 3 below).

The acid neutralizing system consists of three tanks, each filled with calcite media ( $\text{CaCO}_3$ ), with each sized to handle 50% of the building’s estimated domestic water load. This allows for one tank to be off-line for maintenance while the remaining two tanks satisfy the domestic water load. The calcite media is basically comprised of limestone chips which slowly dissolve over time and impart calcium carbonate into the domestic water as the raw water is passed through the media. The calcium carbonate will neutralize acidic or low pH water to a neutral 7.0 pH, thereby raising water alkalinity to a create a less corrosive effluent.
